Performance Evaluation on the Renovation Work for Li-Shan Landslides

M.B. Su¹ H.L. Wu¹ L.C. Chan²

¹Civil Engineering Dept. National Chung-Hsing University

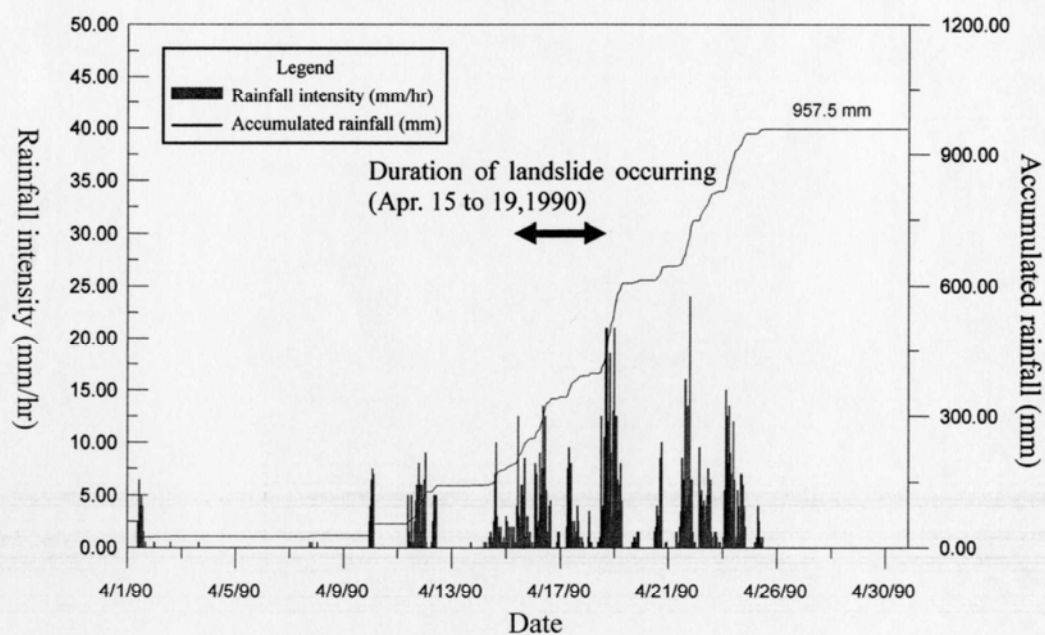
Fig. 2 Precipitation record at Taipower Li-Shan station in April 1990

Background analysis of rainfall record is presented in Figure 2. In the duration of landslide occurring, maximum daily rainfall record was 155.5mm at 19th, which is not very large compared to history record. But, accumulated rainfall between 10th to 20th of April arrived 585mm and total rainfall in April of that year arrived 957.5mm both exceed 50 years return period from rainfall frequency analysis. It can be seen as continuous rainfall can cause large amount of infiltration water to accumulate inside slopes so as to induce landslide. Water infiltrate from ground surface and uphill area and flow into the endangered slope can cause porewater pressure to raise, effective stress within slope to decrease, and break the stability of slope. So, rainfall and groundwater level change are the main triggering factors for this highly weathered rock slope.

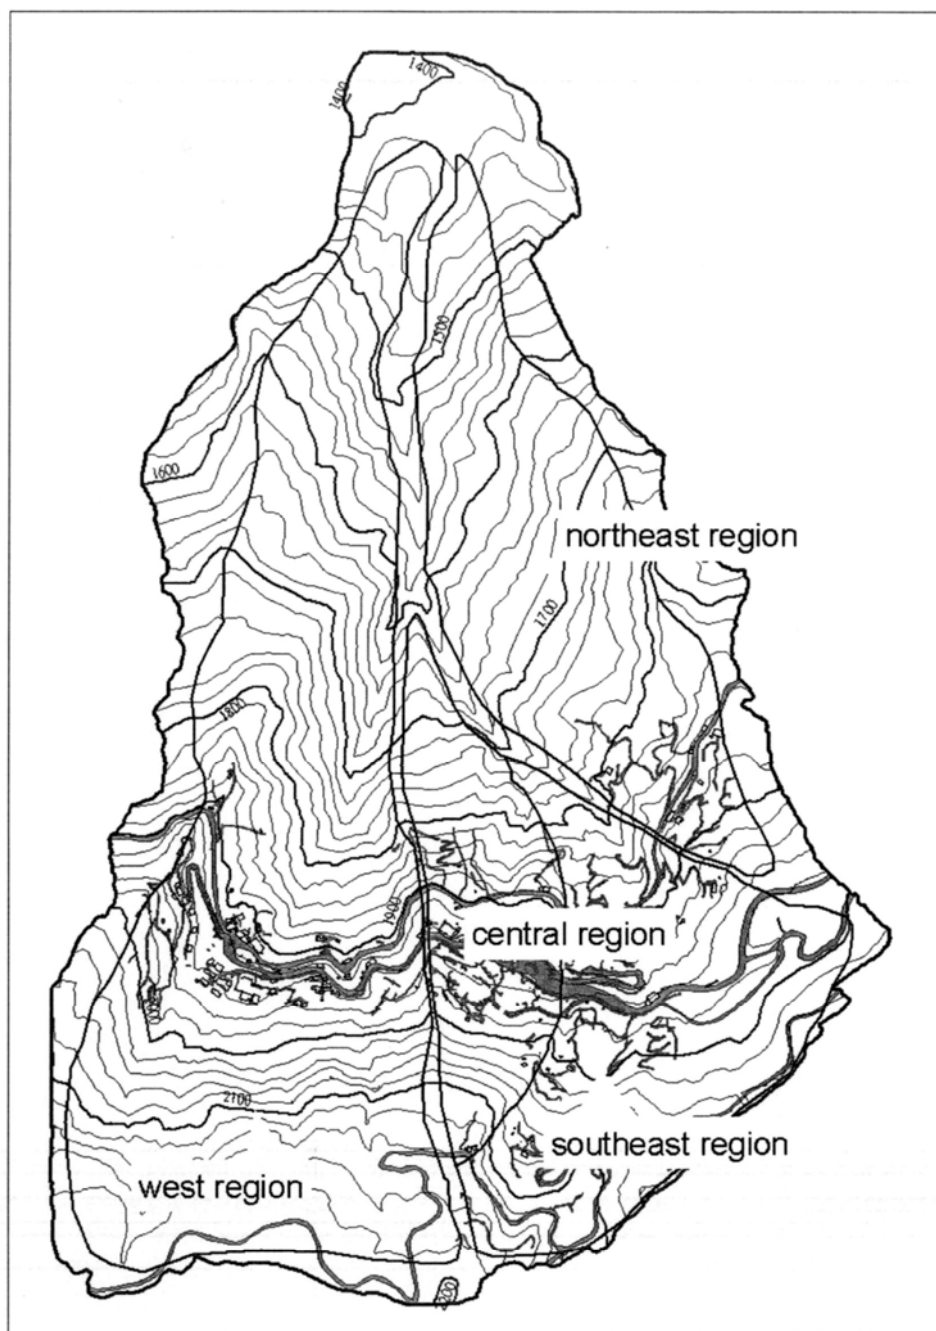
Fig. 4 Division of the four regions in Li-shan landslide area

The landslide area can be divided into four regions, namely central, west, northeast, and southeast regions as shown in Figure 4. Except the southeast region, most of the unstable slopes possess shallow sliding planes at about 9-26 m below surface.

However, there is an old landslide within the central region, of which boundary is adjacent to the southeast region. According to the core logs and the records of drainage gallery construction, the old sliding plane is located more than 40-60 m below surface. The southeast region is more or less at a valley of a small branch of the Ta-Chia-Chi river. Due to the tectonic activities, there is rejuvenation in the Ta-Chia-Chi river. Thus the erosion rate of this branch is quite high, which generate higher landslide hazard potential for this subregion.

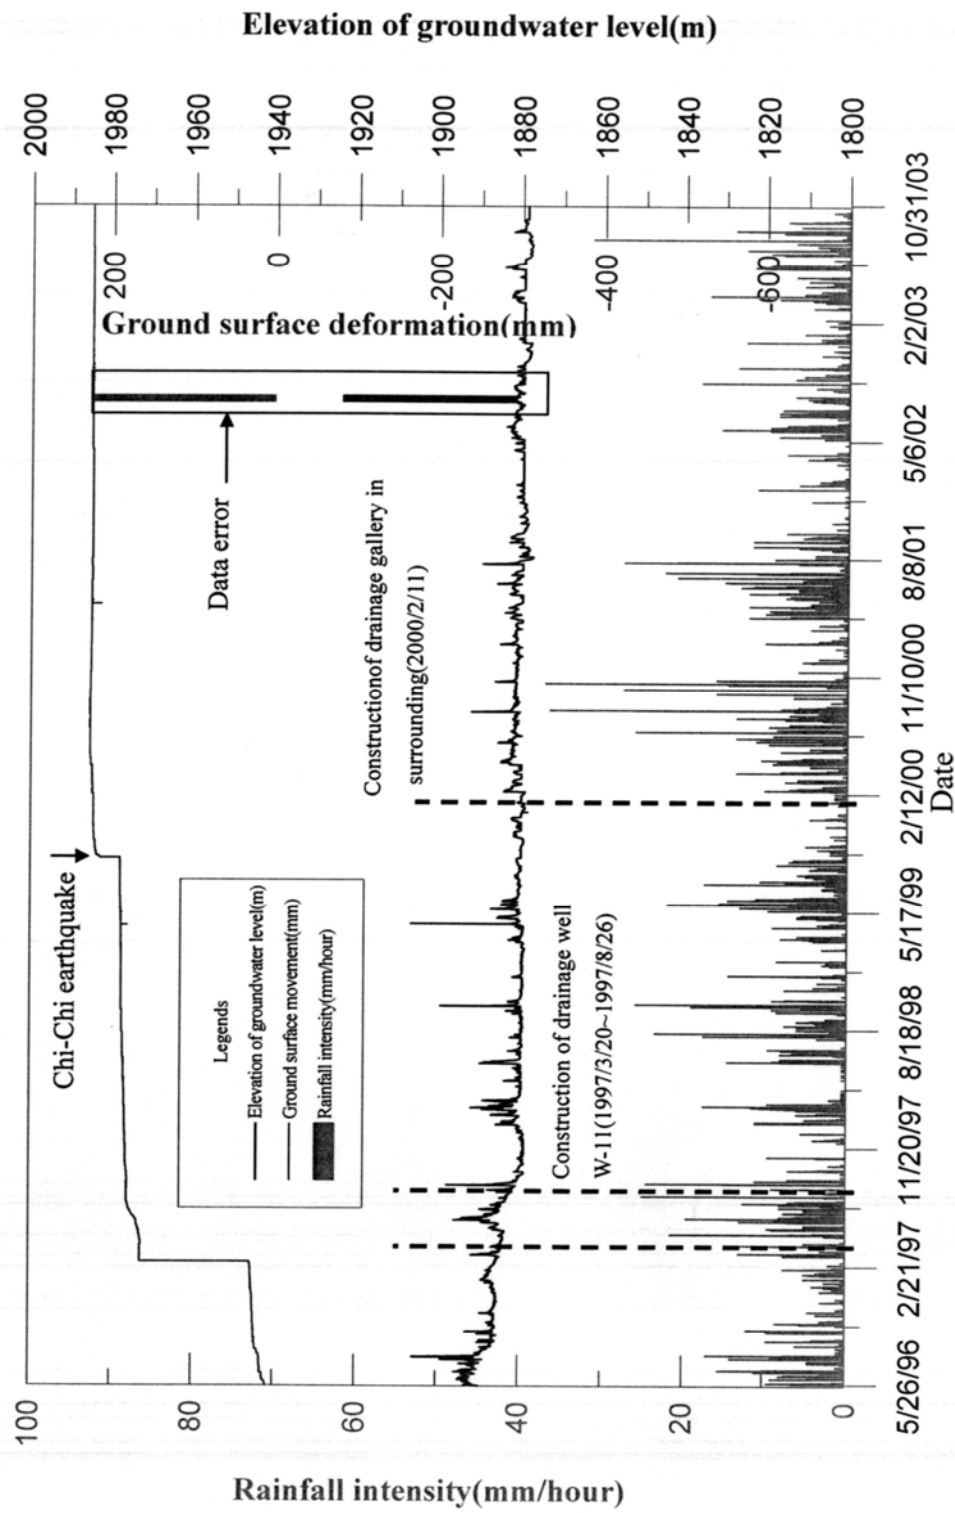
Fig. 7 Relation between rainfall intensity, groundwater level and surface deformation in B1 station during 1996/5~2003/10

B1 station located at west side of central region which is the bottom of a series of sliding blocks. There are B2, B5, and B8 block in above. Data for rainfall, groundwater level change together with surface movement are put together in Figure 7 for comparison. As can be seen from the Figure, during construction of drainage wells, groundwater level dropped for more than 10 meters and certain amount of surface deformation happened. After that, ground showed quite stable. But, rise of groundwater level were large during rainstorm seasons until drainage gallery pass through this area. After that, groundwater level remained quite stable.

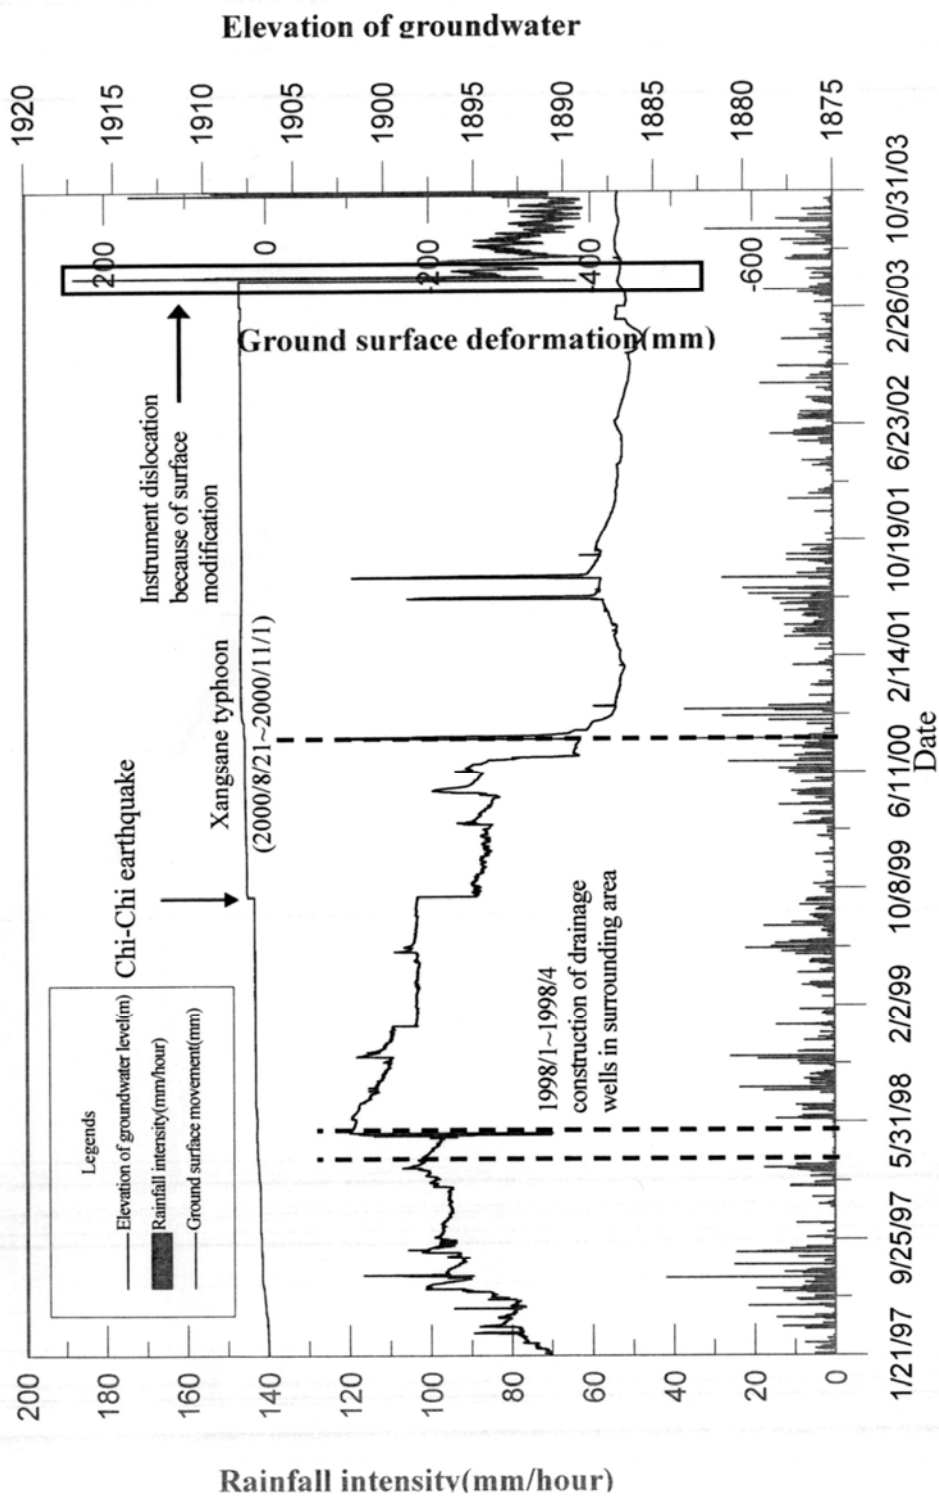
Fig. 8 Relation between rainfall intensity, groundwater level and surface deformation in B4 station during 1997/1~2003/10

B4 sliding block is located in front of the colluvium of the central region which is very close to the major highway. Monitored data showed fairly large variation. In the early time, construction of drainage well showed no effect in lowering the groundwater level. But, when construction work approaching surrounding area,

groundwater level dropped significantly. After that, it kept stable in elevation 1887m(m.s.l) till now.

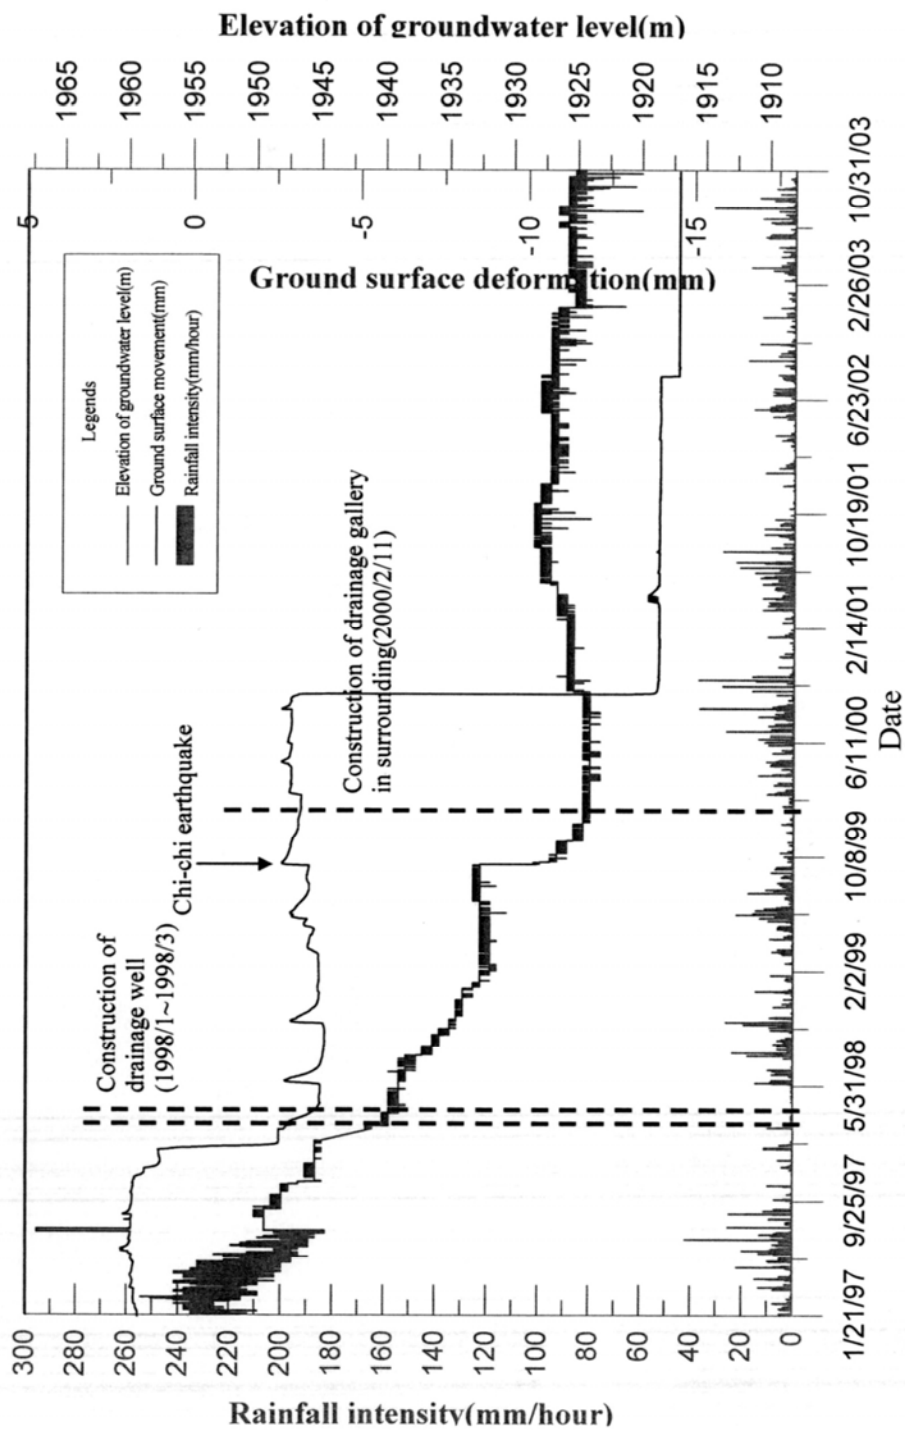
Fig. 9 Relation between rainfall intensity, groundwater level and surface deformation in B5 station during 1997/1~2003/10

B5 sliding block is located uphill of B1 which has many important building on it. In Fig. 9 groundwater level monitored showed a minor drop during drainage well construction but had a very large drop when drainage gallery pass underneath. Extensometer on the ground surface showed no significant change is maybe because of the location of fixed point turn out to be on another sliding block.

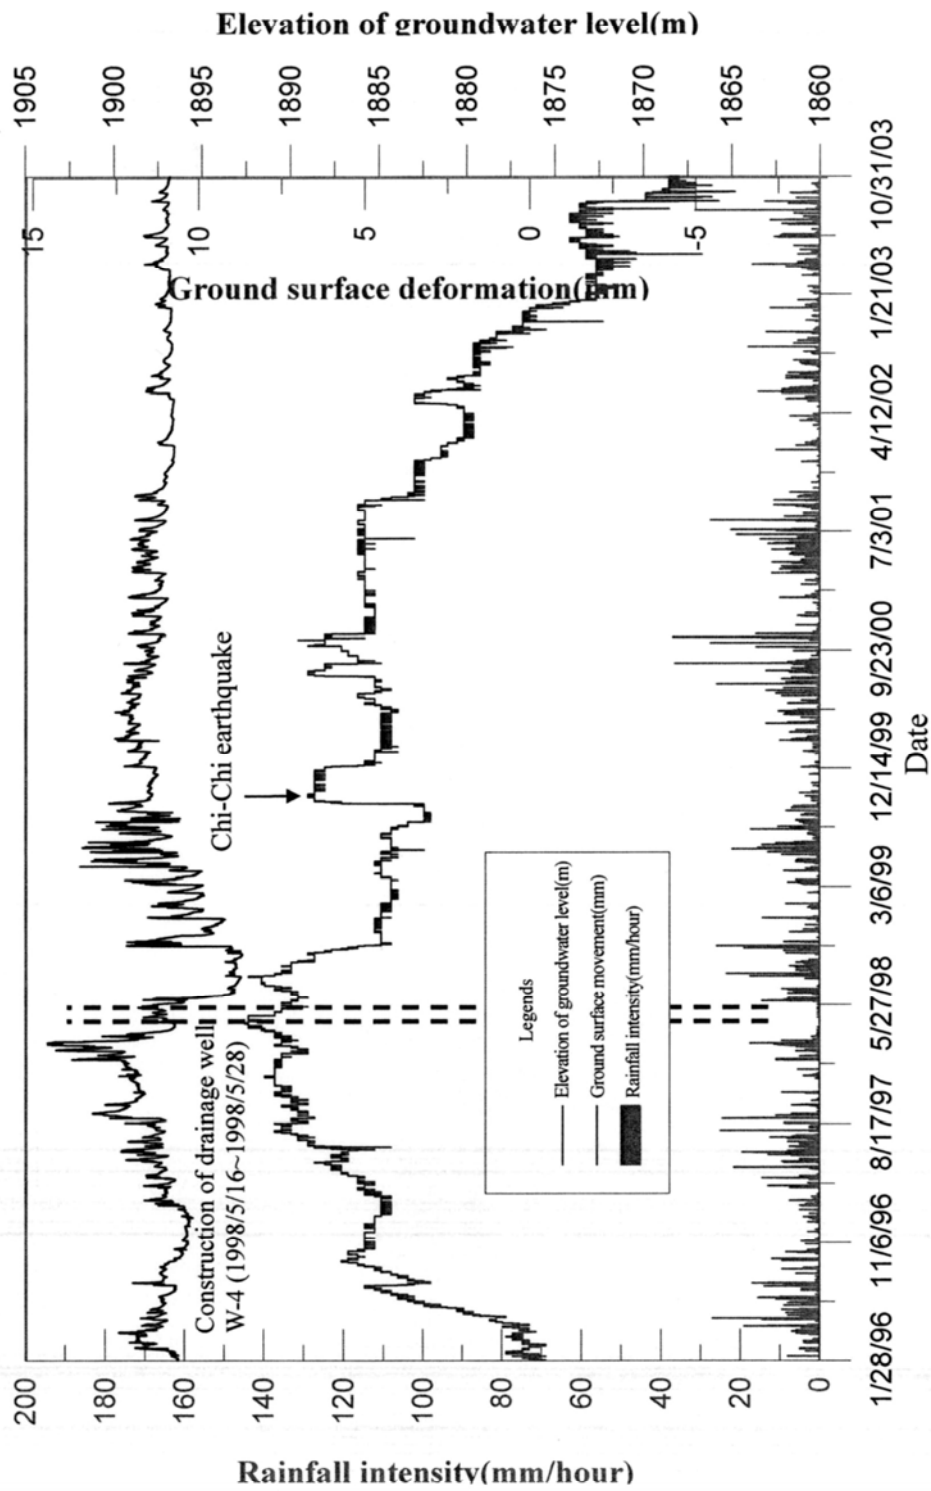
Fig. 10 Relation between rainfall intensity, groundwater level and surface deformation in B9 station during 1996/1~2003/10

B9 sliding block is located to the East of B4 and B5 block. It is the front block of a series sliding block on southeast region. It has a major building called citizen Hotel sitting on it. The building was quite huge and has a very good view looking into Da-cha river, but building had evaluated unsafe right after the major li-shan landslide occurred on april 1990. And now (2004), the building was teared down and the site remolded into a rural garden.

As can be seen for graph of the recorded data, construction of drainage well did showed effects on groundwater level. Drainage tunnel seems didn't lowered the groundwater level but limited the magnitude of fluctuation of groundwater level. Removing of the building was believed can improve the stability of the sliding block.

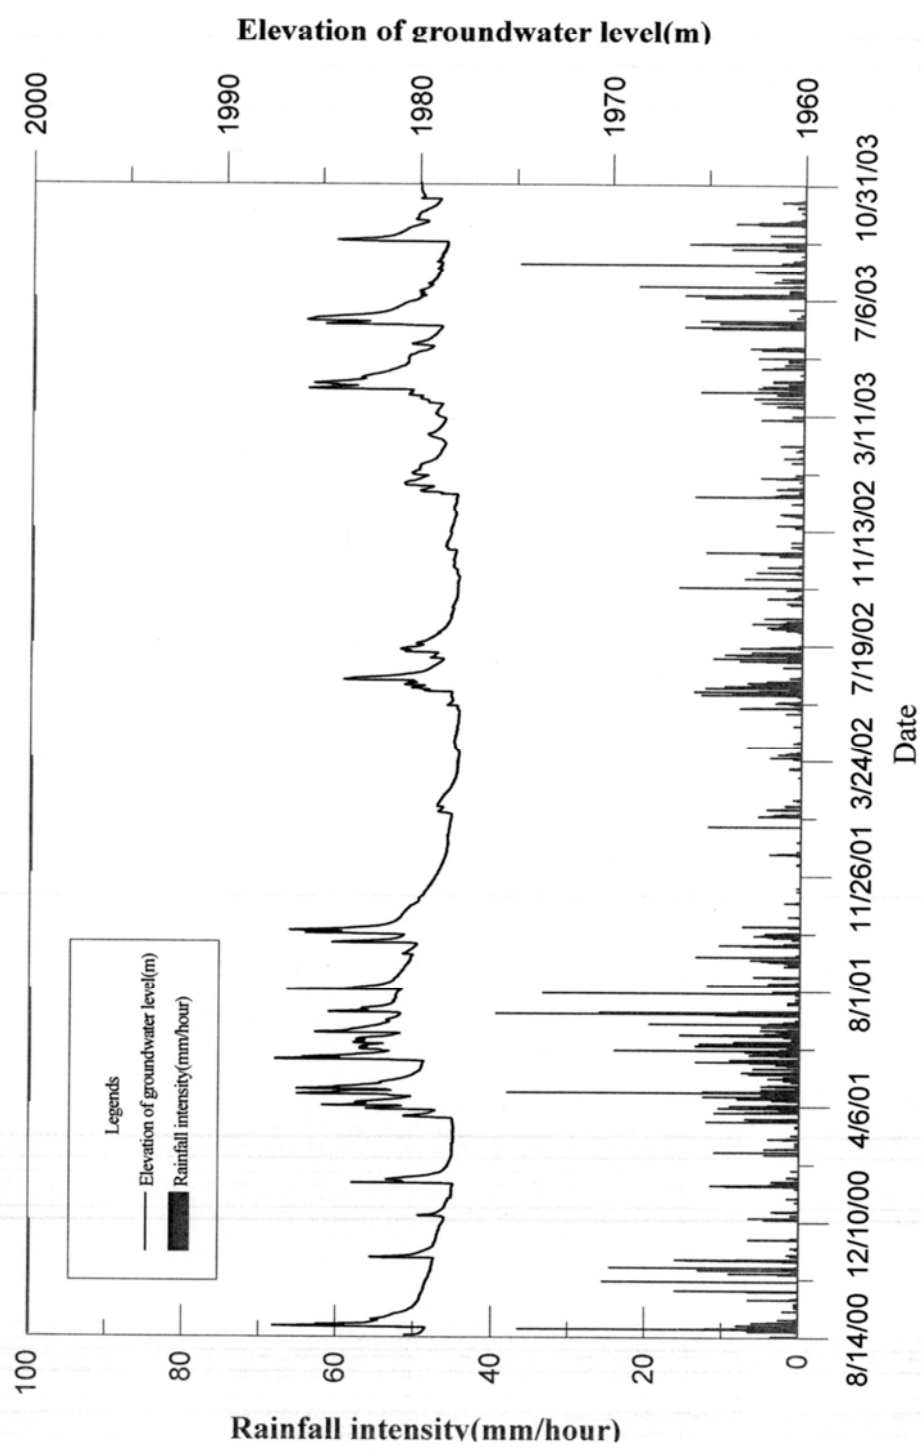
Fig. 11 Relation between rainfall intensity, and groundwater level in B11 station during 2000/8~2003/10

B11 block is located uphill of B9 block. The monitoring station was set lately on year 2000. Groundwater elevation has great correlation to rainfall intensity. No significant effect on construction work observed.

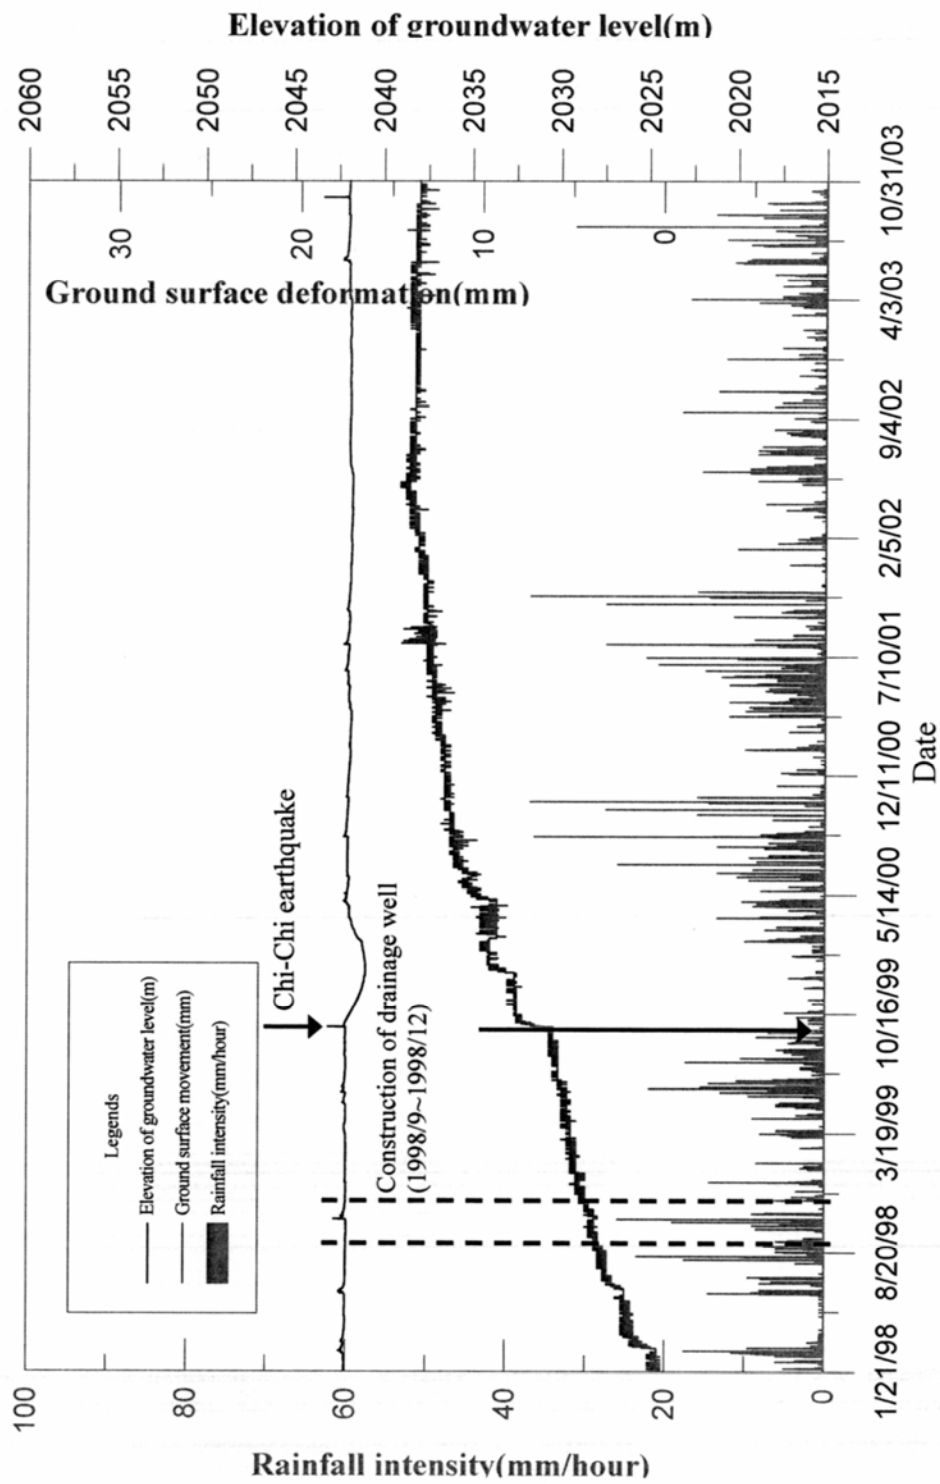
Fig. 12 Relation between rainfall intensity, groundwater level and surface deformation in B13 station during 1998/1~2003/10

B13 block is located uphill of B11 and B9 block and form a headwater sequence more like retrogressive sliding in a complex form and was judged still unstable and developing headward. Groundwater level recorded showed very little connection to the rainfall. It kept groundwater level dropped during Chi-Chi earthquake and recovered gradually. It was judged that the groundwater here is in confined situation and more investigation showed be performed to study it characteristics.

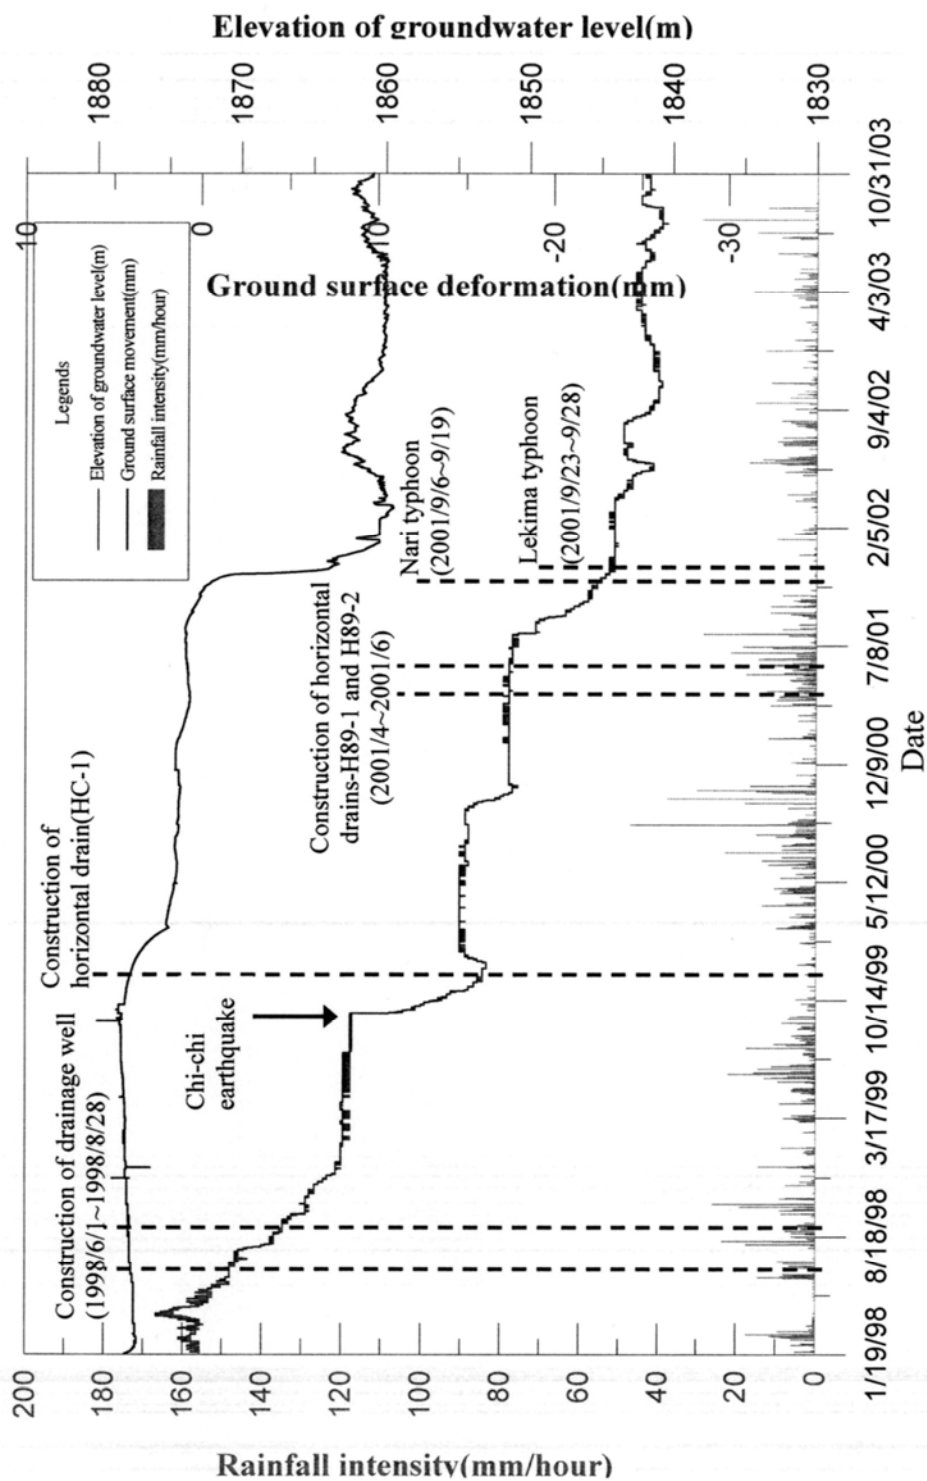
Fig. 13 Relation between rainfall intensity, groundwater level and surface deformation in C1 station during 1998/1~2003/10

Record presented in Figure 11 for C1 station showed great influence of groundwater level to the remedial work. Total drop of groundwater level was more than 10 meters especially after construction of horizontal drains and Nari typhoon hitted. C2 station showed no significant fluctuation of its groundwater level. More study showed be conducted here.
