# **INTERNATIONAL CONFERENCE ON SLOPE ENGINEERING**

# **RISK ESTIMATION OF THE LI-SHAN LANDSLIDE IN TAIWAN**

Keh-Jian Shou<sup>1,2</sup> and Miao-Bin Su<sup>1</sup>  
<sup>1</sup>Professor, Department of Civil Engineering,  
National Chung-Hsing University, Taiwan  
<sup>2</sup>Visiting Professor, RCUSS,  
Kobe University, Japan

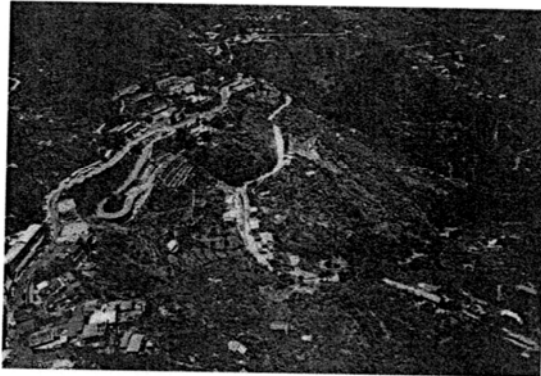
Picture 1. A bird eye view of the Li-shan Landslide area (looking to the southwest).

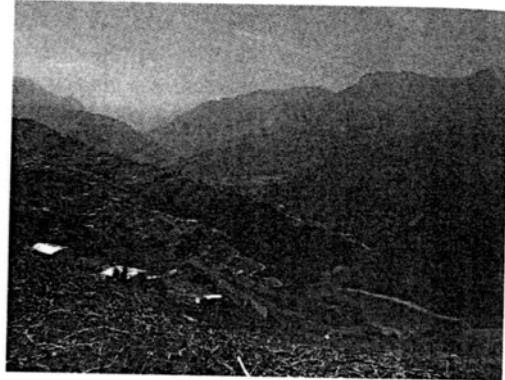
Picture 2. The rejuvenation in the Tachiachi river makes the toe steeper than the head.

The landslide area can be divided to three regions, i.e. the west, northeast, and southeast regions (see Figure 1). Except the southeast region, most of the unstable slopes possess shallow sliding planes about 9-26 m below surface. However, there is an old landslide within the southeast region, of which boundary subdivides the southeast region to two subregions. According to the core logs and the records of drainage gallery construction, the old sliding plane is more than 40-60 m below surface. The rest of the southeast region is more or less located at a valley of a small branch of the Tachiachi river. Due to the tectonic activities, there is rejuvenation in the Tachiachi river. Thus the erosion rate of this branch is quite high, which generate higher hazard potential of this subregion (see Picture 2).

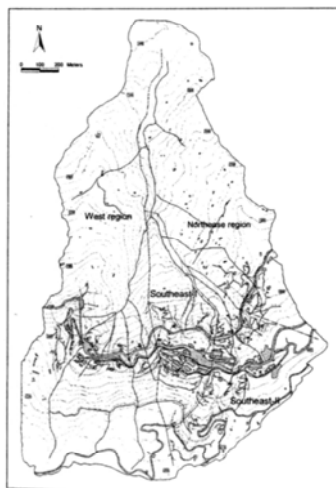
Figure 1. The topography and divisions of the Li-shan landslide area.

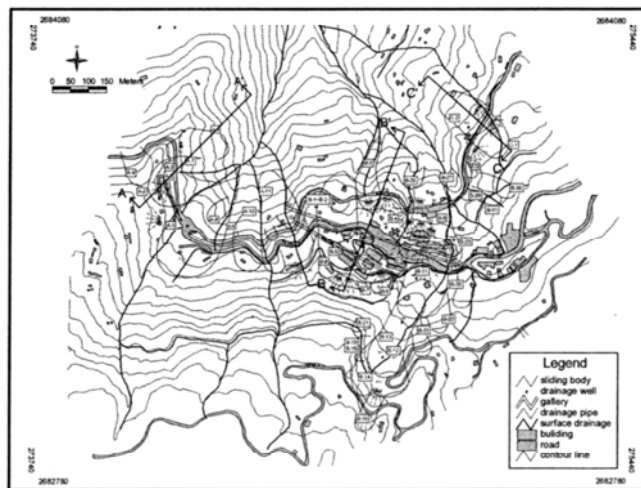
Based on the study of topography, the profiles AA', BB' and CC' (see Figure 2) were adopted and analyzed by the limit equilibrium analysis model PC-STABL [3]. The slopes are fairly stable for dry condition as the safety factor is 1.21-1.35; but they become critical with high groundwater level as the safety factor drops to 0.99-1.15. This finding might reveal there are more than one activities in this area, as the precipitation is quite high in this area, about 2340 mm annually. Therefore, it is essential to have remediation treatment in this area (see Table 2). Besides, during the Chi-Chi earthquake, the horizontal acceleration was estimated 0.15-0.20g. With this impact, this area survived except minor damages near the profile BB'. It somehow reveals the effectiveness of the remediation.

Figure 2. Illustration of the remediation treatment in the Li-shan landslide area.

As the landslide is closely related with the rainfall and groundwater, groundwater control is essential to for slope stabilization in this area. A drainage system, composed of surface and subsurface drainage components, was designed to be a remediation treatment. For the surface drainage system, existing ditches were integrated as a system to divert the water undesirable surface flows into non-problem areas, as well as to prevent excessive water infiltration near tension cracks. In order to more efficiently control the groundwater level, a subsurface drainage system is also applied, which is consisted of three major components, i.e., horizontal drainage pipe, drainage well, and drainage gallery. There are (1) 15 horizontal drainage sites, 7-9 pipes (30-60m in length) in each site, (2) 13 drainage wells, located major in the heads of slopes, and (3) 2 drainage galleries, excavated below the sliding planes. The surface and subsurface drainage systems are illustrated in Figure 3.

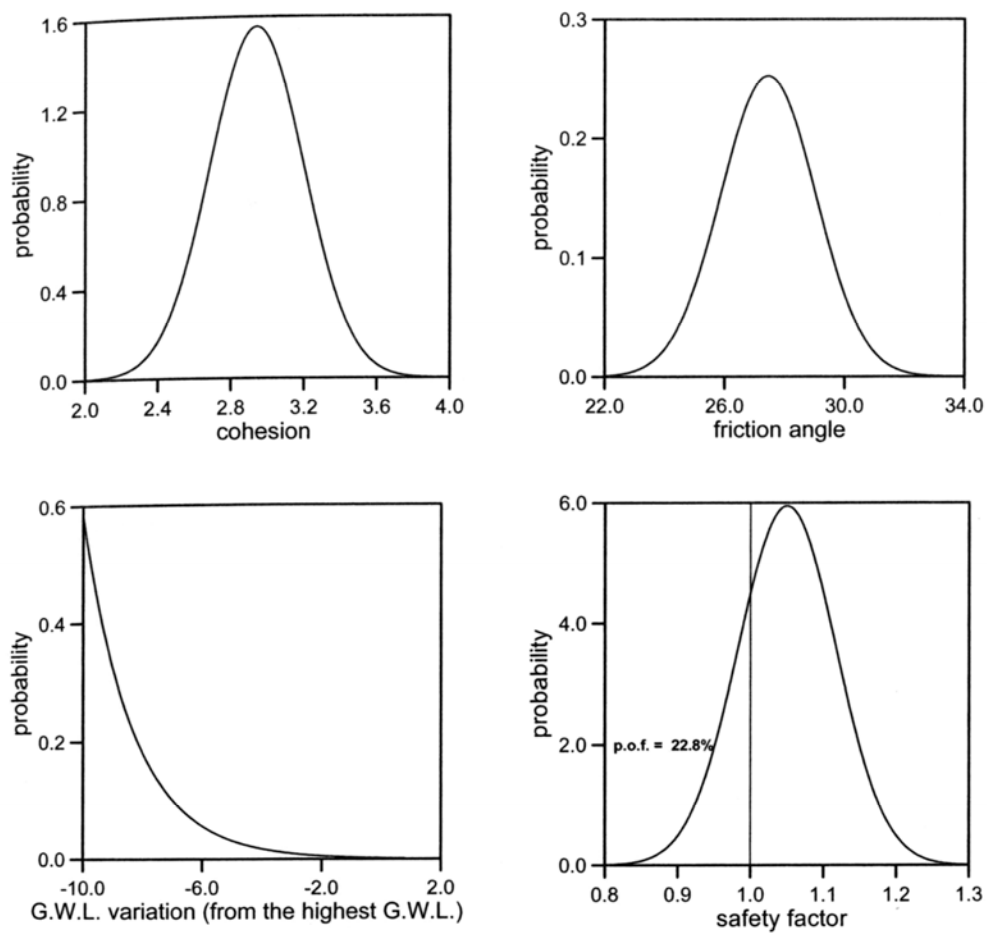
Through the Monte Carlo probability analyses with 10000 iterations, the risk for the most critical profile BB' is about 22.8 % (see Figure 3). This means that, for the combination of parameters with the assumed variations, 23 out of 100 similar slope could be expected to fail at some time during the life of the slope. However, the risk reduces to 1.0 % if we count on the contribution of remediation (see Figure 4). Therefore, the groundwater condition will still control the stability of the residual slope. It suggests that more attention should be given to the residual slopes with higher groundwater level, especially during rainy season.

Figure 3. Risk analysis of Li-shan landslide (profile BB', before remediation).

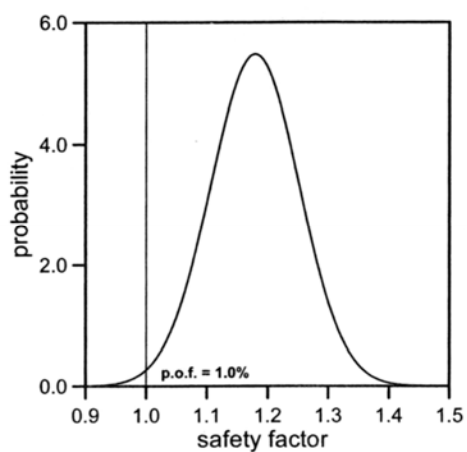
Figure 4. Risk of profile BB' after remediation (G.W.L. 20m lower).

The risk analysis shows that the risk of slopes is about 22.8 % with high groundwater condition. The risk reduces to 1.0 % if we count on the contribution of the remediation treatments. However, attention should be given to the potential problem caused by the high erosion rate of the nearby streams. For the risk assessment, it is essential to adopt a threshold value for the risk (an acceptable risk), in which social and economic impact must be considered.
