Japan-U.S. Workshop  
on  
Snow Avalanche, Landslide, Debris Flow Prediction and Control

LANDSLIDE MECHANISMS OCCURRED IN A COLLUVIUM SLOPE DEPOSIT

Miau-Bin Su,  
Associate Professor, Civil Engineering Department,  
National Chung-Hsing University, 250 Kuo Kwan Rd,  
Taiwan, R.O.C

**SUMMARY;** A case study was conducted at a landslide located on an ancient colluvium deposit. The mechanism of this specific landslide involves a weak sandy clay layer together with seepage force exerted by groundwater flow during large rainstorm.

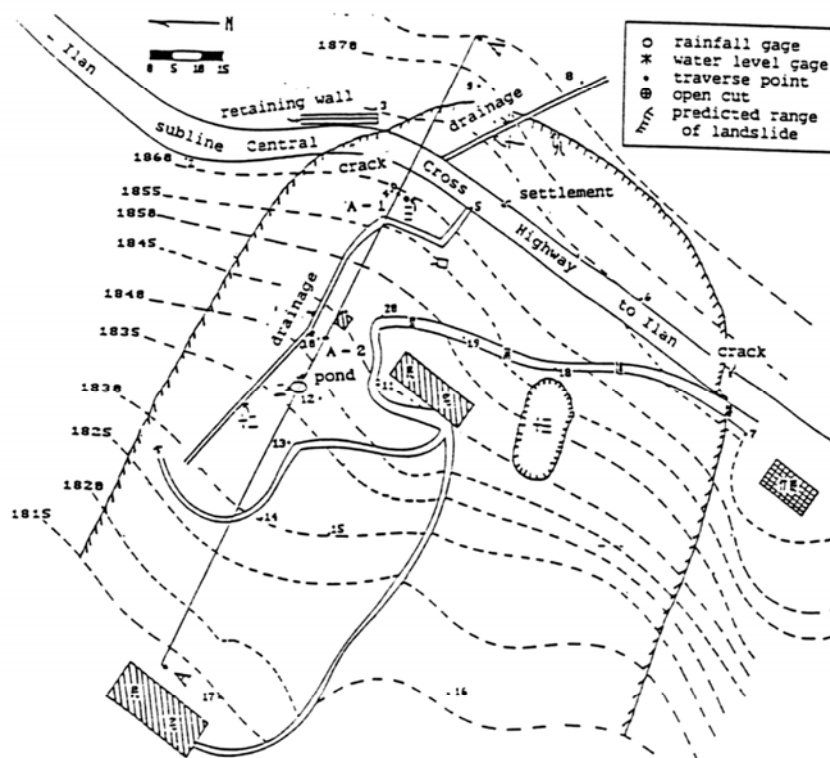
Figure 3. Study area in 72K-500 in Central Cross Highway

The study site is on the 7-A subline 72K+500 of the Central Cross Island Highway to Ilan(Fig.2). Land use of the area is fruit tree plantations. The landslide has continued for a long time. And the only control practices are a drainage system and the retaining wall with

the height of 1.4m and length of 20m(Fig.3). When rainfall continues for several days, a small pond forms at the base by seeping water.

In this study, two drilled holes, located in A-1 and A-2 (Fig.3), were set up to measure the variation of groundwater level. The depth of holes A-1 and A-2 were 20 and 13m, respectively. After the drilling, 5cm PVC protective casings were buried with open holes in the bottom and walls of the lowest were packed with geotextile. An automatic water level gage was situated on a concrete stand on top of the well. The cycle of recording was 30-day, the same as the rainfall gage.

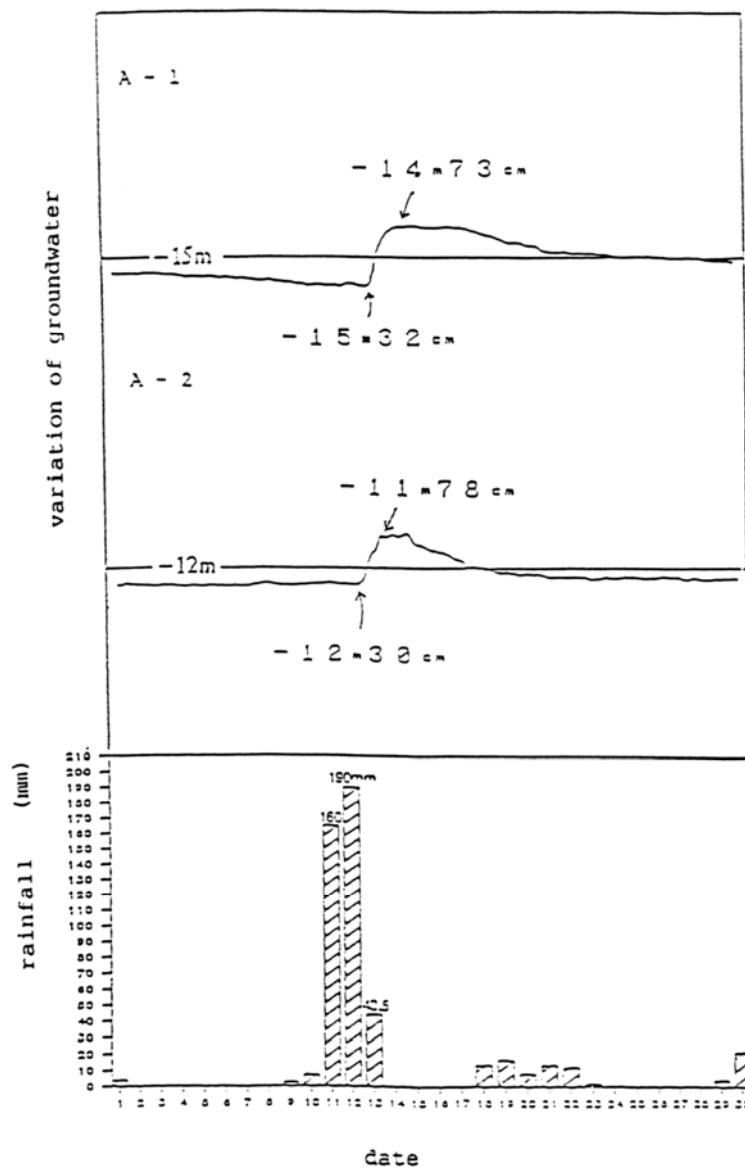
Figure 4. Rainfall-Ground water level relationship during September, 1989

During the measuring period, the maximum variation of groundwater level occurred in September, 1989 during typhoon Sarah. Total precipitation was 400mm during three consecutive days and the groundwater level rose about 50-60cm (fig.4). In October, 1989, both of the protective casings distorted and measurements were interrupted.

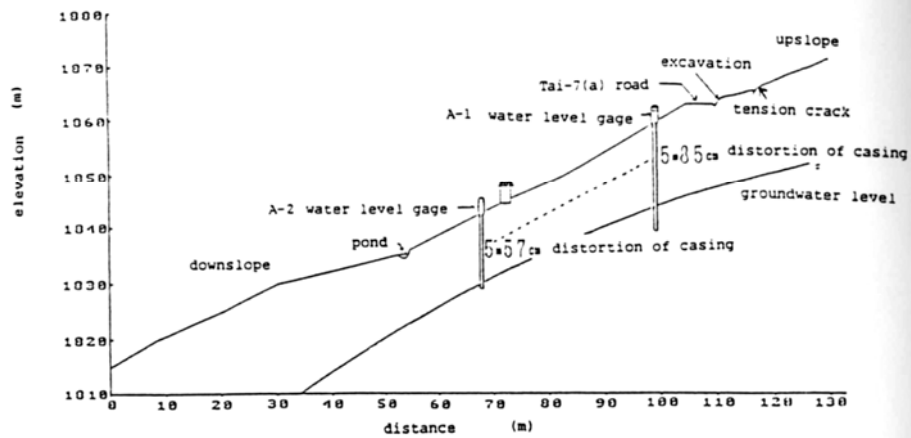
Figure 5. Measuring result of sliding surface of section A - A

Depth of the sliding surface was estimated from the position of distortion of the PVC casings. In October, 1989, the position of distortion depth for A-1 was at 5.85m from the ground surface, and that for A-2 was at 5.57m (Fig.5). Consequently, sliding surface is nearly parallel to the land surface in this area.

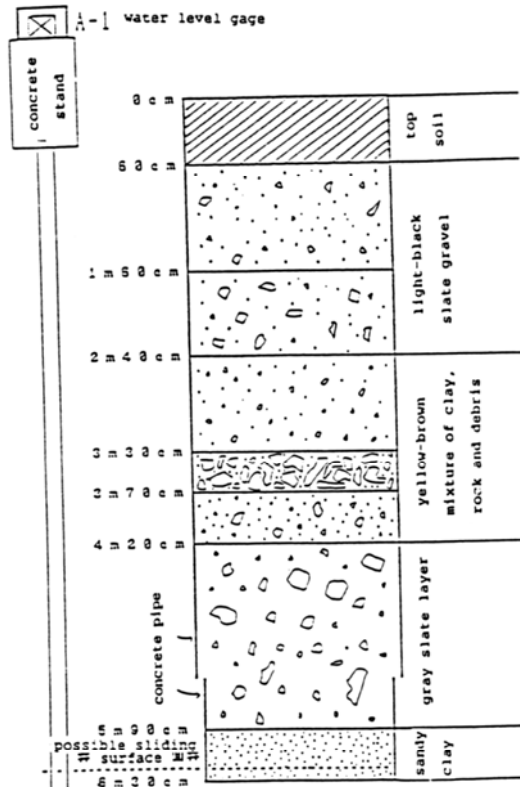
Figure 6. Diagram of test well

A site near A-1 and A-2 was selected for sampling. Vegetation and top soil to a 60 cm depth were removed with 60cm in depth was also removed. The procedures of excavation of the test well and the description for geology are as follows (Fig.6) :

In open cut at A-1, the soil particles were sampled from 0.6m to 1.6m, which the  $D_{max}$  is 18cm. The particle size was larger in deeper zone .  $D_{max}$  for the zone was about 30cm. Since the seeping water existed at depth of 2.1m, 2.15m, 2.3m, and 2.4m , the path of groundwater level may be related to the pore space formed by the larger particles.

From 2.4m to 3.3m is the slate-clay soil particle size is  $<5\text{cm}$  and the seeping water occurred at 2.7m. The zone from 3.3m to 3.7m contains a mixture of clay and slate ( $D_{max} > 50\text{cm}$  ). The mixture of clay, rock, debris, and detritus located from 3.7m to 4.2m had average particle size smaller than 15cm with seeping water at 3.85m and 4.5m .

The formation in this zone is composed of gray rock, gravel, and debris. The permeability is high and  $D_{max}$  is about 32cm.

e). Below 5.9m: sandy clay layer with debris.

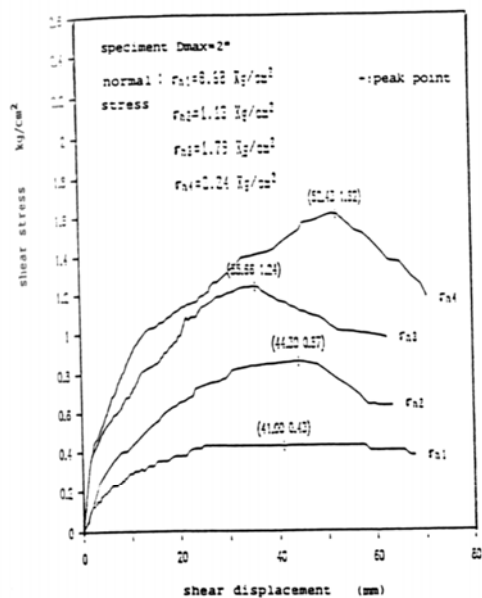
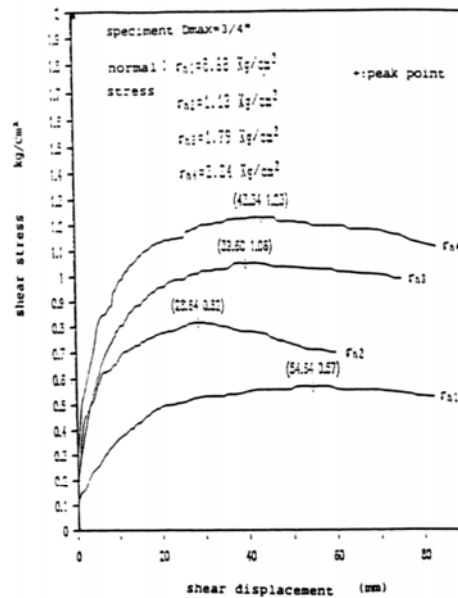
The large scale direct shear apparatus was used in the CU (consolidated-undrained) test, which the grain size of the specimen was prepared with sieve size of 5cm, 2cm, #4, #8, #16, #30, #50, #100, and #200. Results of the tests are shown in fig.7 and fig.8 which  $c=0.03\text{kg/cm}$ ,  $\phi=35^\circ$  for the specimen of  $D_{max}=5\text{cm}$  and  $c=0.35\text{ kg/cm}$ ,  $\phi=21.56^\circ$  of  $D_{max}=2\text{cm}$ .

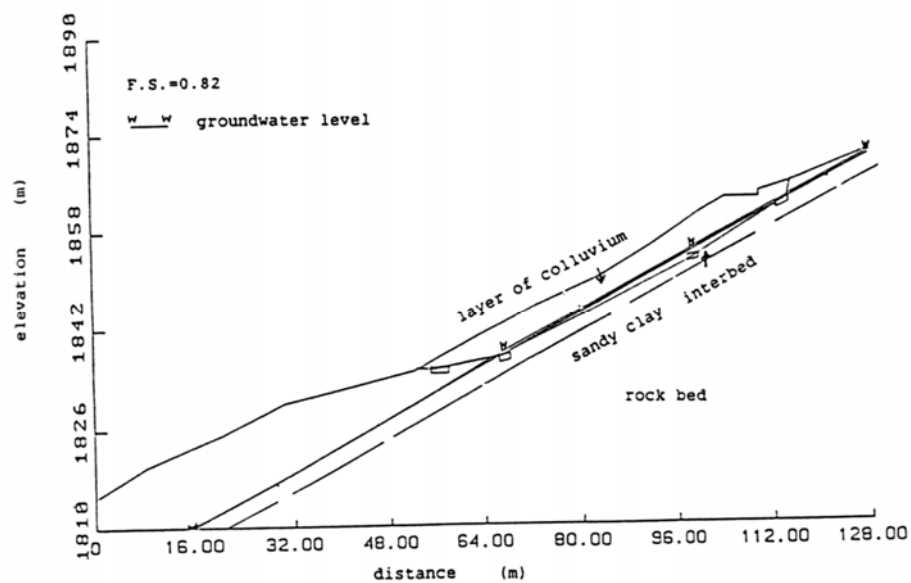
Figure 9. Result of slope satability analysis of section A - A

Because the groundwater level between A-3 and A-1 differed about 9m, This implies that two or more groundwater zones exist. In the direct shear test,  $C$  increased as the content of fines in specimen increased. When the content of fines was more than 60%, the variation of  $C$  was less (Fig.10), and the value approached a constant when the content of fines was more than 78% (Fig.11). The factor of safety (FS) of slope stability was obtained after the analysis of PC STABL5, which  $F.S.=0.82$  (Fig.9).

- (1) the poorness of the drainage systems which differs the groundwater level of shallow stratum.
- (2) poor ground surface covering which increase the infiltration.
- (3) heavy transportation load.
- (4) the weak sandy clay layer forming the sliding surface.
- (5) the seepage force exerted by infiltrated groundwater flow.
- (6) weathering of the colluvium material which decrease the shear strength of it.
