## 治山防災與坡地環境國際研討會

# **Landslide Remediation Work and Treatment in Taiwan**

*Miau-Bin Su<sup>1</sup>, S.M. Chang<sup>2</sup>, Y.S.Yen<sup>3</sup>*

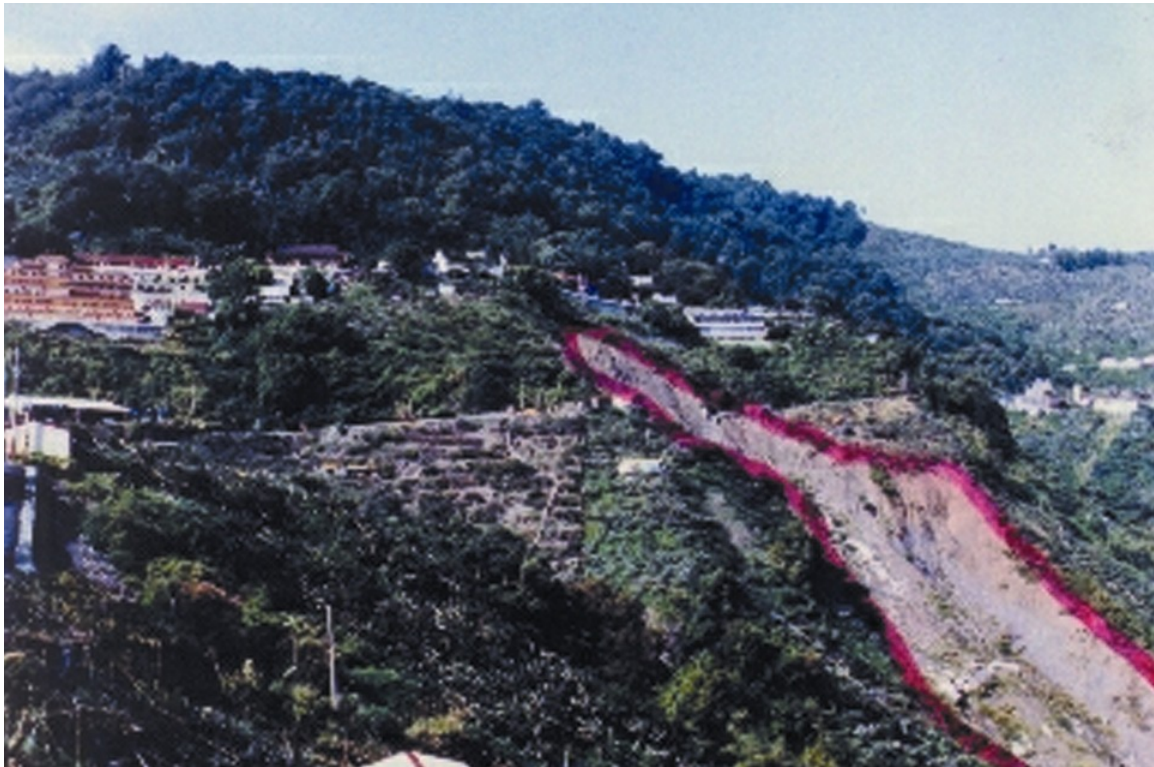
Fig.3 Landslide at route 7A 73k+150

A continuous heavy rain hit Li-Shan area on April 11, 1990. Consequently, the slope, near the highway 7A(73K+150) started to slide down on April 15. The sliding body measured about 100m wide, 150m long, and 20m in thickness. About 300,000 cubic meters of the total debris

were sliding down to an erosion trench which is a branch of Ta-Chia river flowing down to the Teh-Chi Water Reservoir. As the sliding body crossing highway 8 and 7A, all the communication and transportation were interrupted.

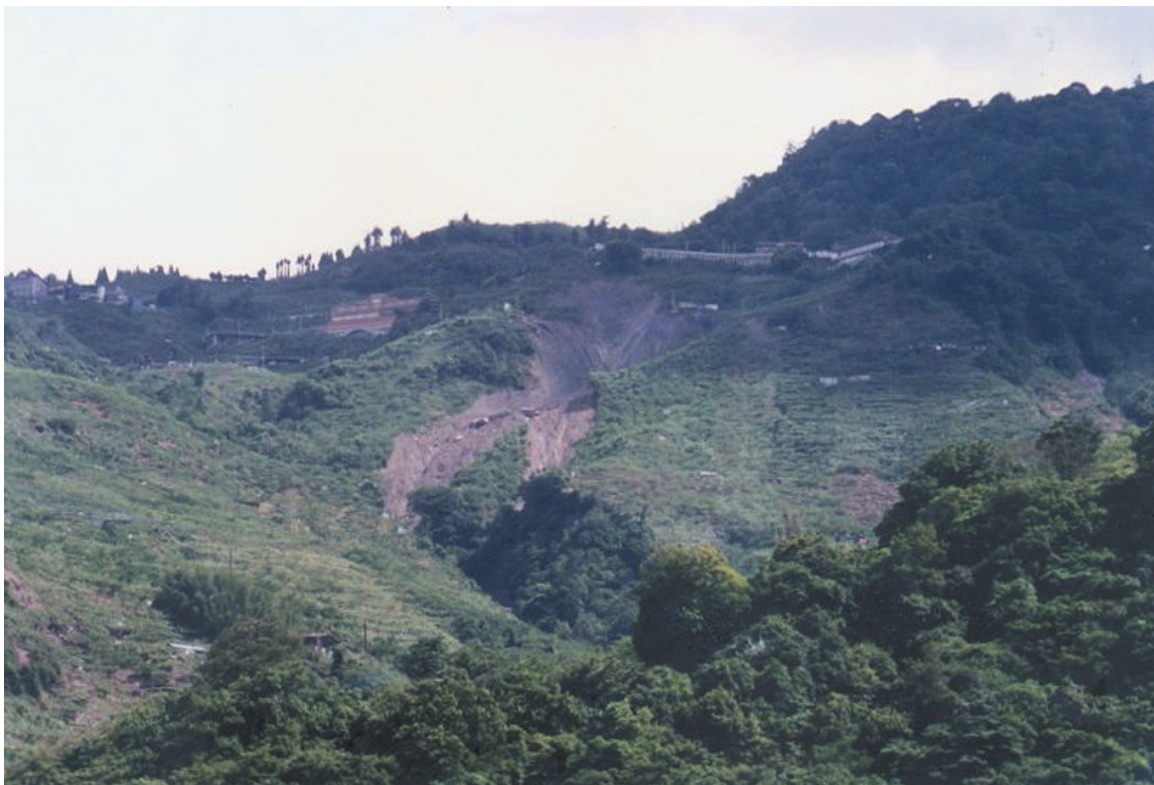
Fig.4 View of landslide from Tachiachi river

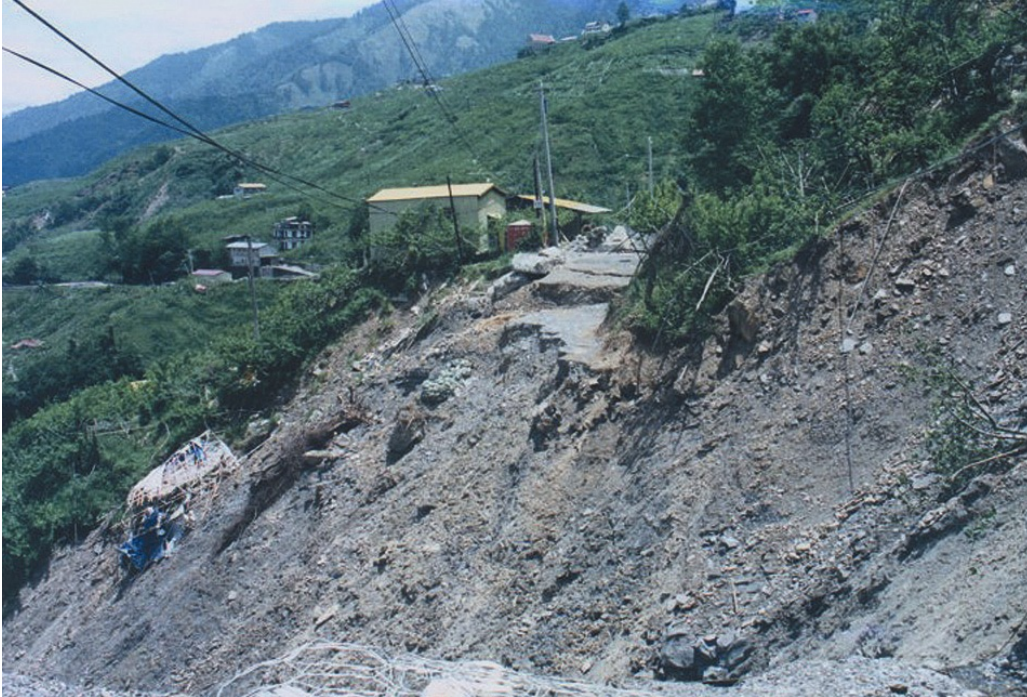
Fig.5 Landslide causing destruction on route 7A

The damage on highway route 7A is near 73K+150, which includes cracking and failing of retaining walls and uneven cracks on the floor. The affected area extended from the west side of Li-Shan Grand Hotel to the east side of Li-Shan Civil Hotel. About 320 m pavement in length along highway route 7A was destroyed. The destruction of nearby buildings was serious. Reports of soil-boring indicate that the damage area was mainly located on the upper part of sliding blocks.

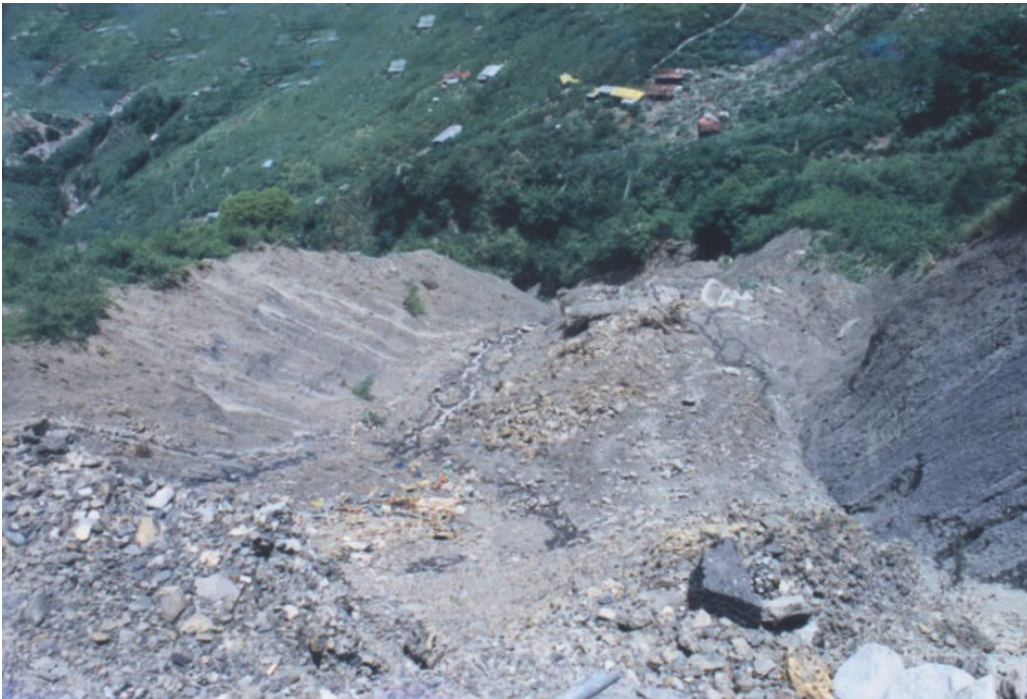
Fig.6 Subsidence of pavement on route 7A

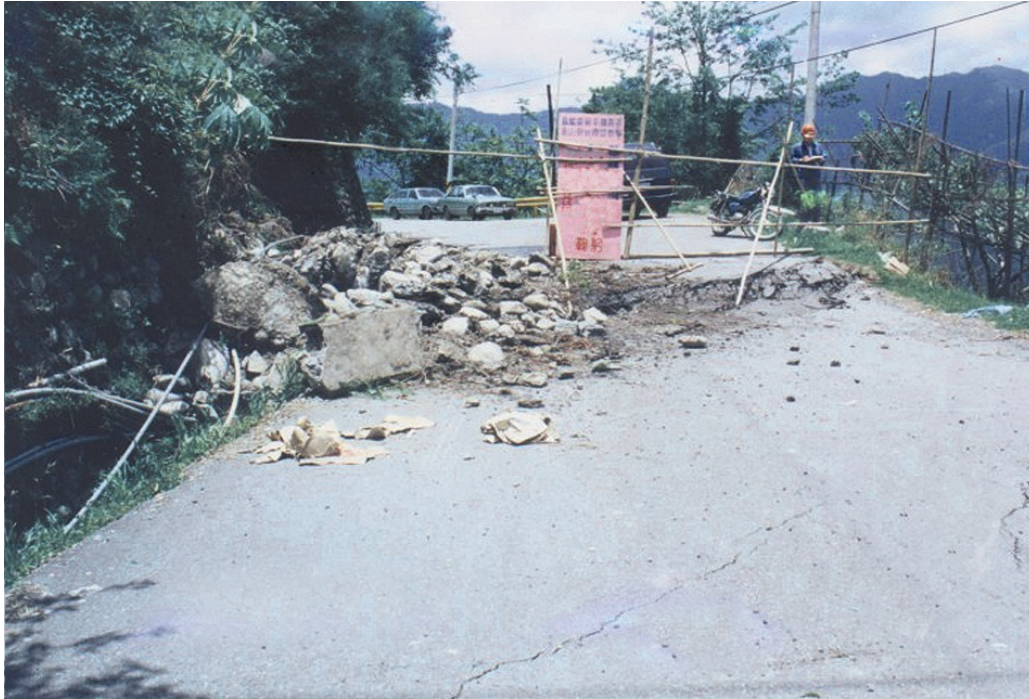
Fig.7 Top view of landslide along route 7A

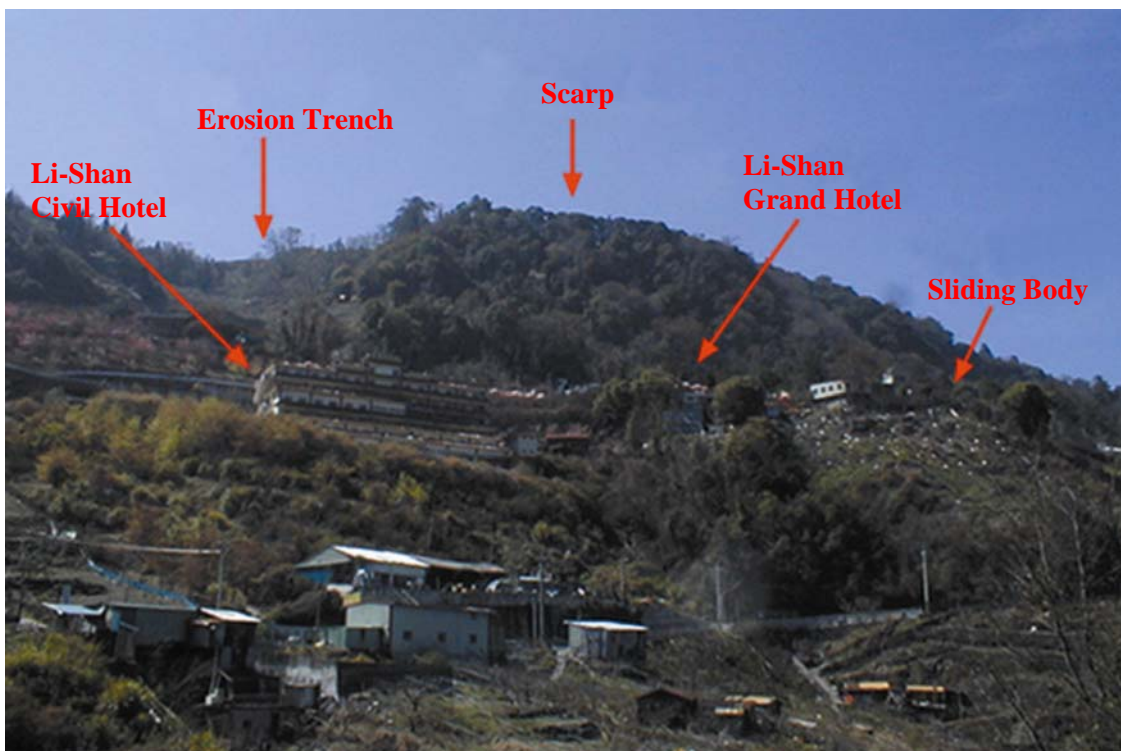
Fig. 8 View of Li-Shan landslide

Based on the investigations, it could be recognized that Li-Shan has experienced more than one landslide activity in the history. The horseshoe shape of topography (scarp behind the Li-Shan Grand Hotel) with a convex ridge (front of sliding body) to the north is a strong evidence for a major previous landslide.

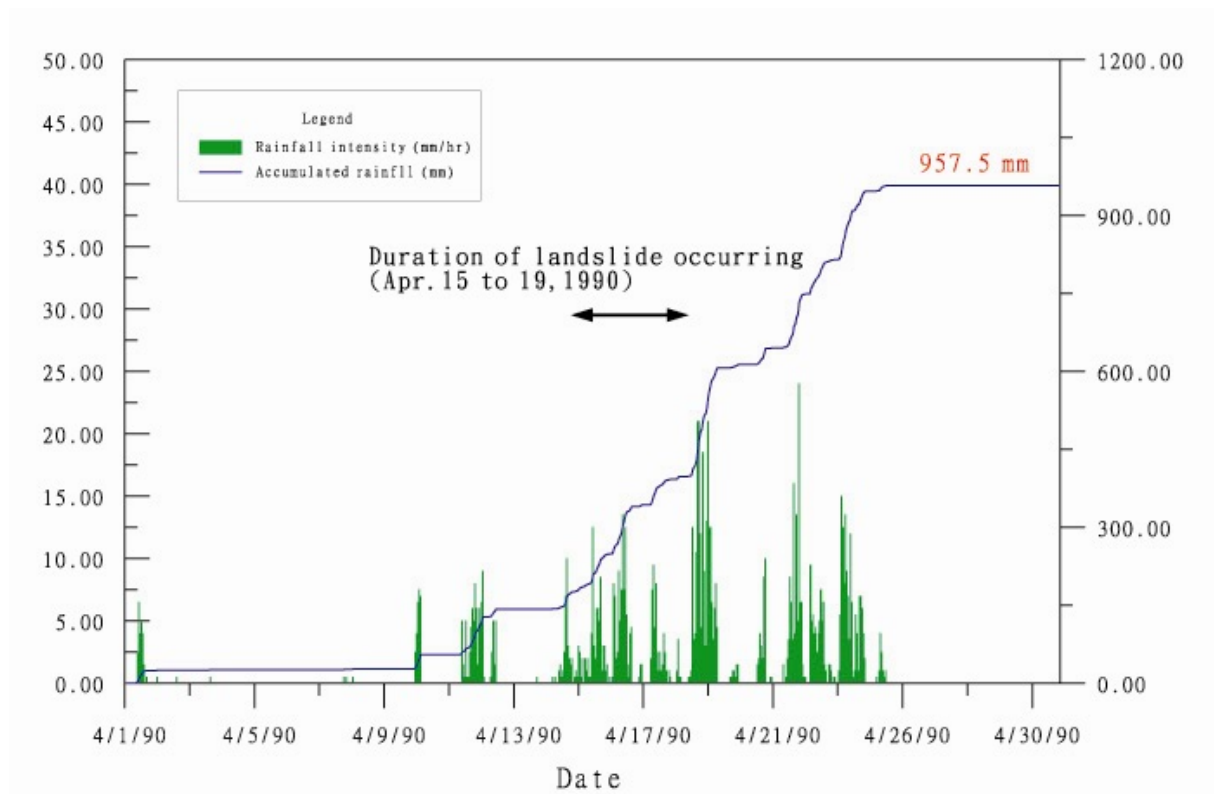
Fig.9 Precipitation record at Taipower Li-Shan station in April 1990

The rainfall record in April, 1990 was shown in the figure. It could be found that the maximum daily rainfall recorded during the landslide disaster is not very large compared to the previous record in the history. However, the accumulated rainfall of 585 mm from April 10th to 20th and the monthly rainfall of 957.5 mm in April show that both rainfalls exceeded the record of 50 years return period based on the frequency analysis. The continuous rainfall could cause a tremendous amount of water infiltrate and accumulate inside the slope. The infiltrated water could increase the pore water pressure, subsequently decrease the effective stress in the rock mass and resulted in the instability of the slope. Based on this, it could be confirmed that the rainfall induced the increase of water pressure is the main factor which triggers the landslide of the highly weathered rock slope.

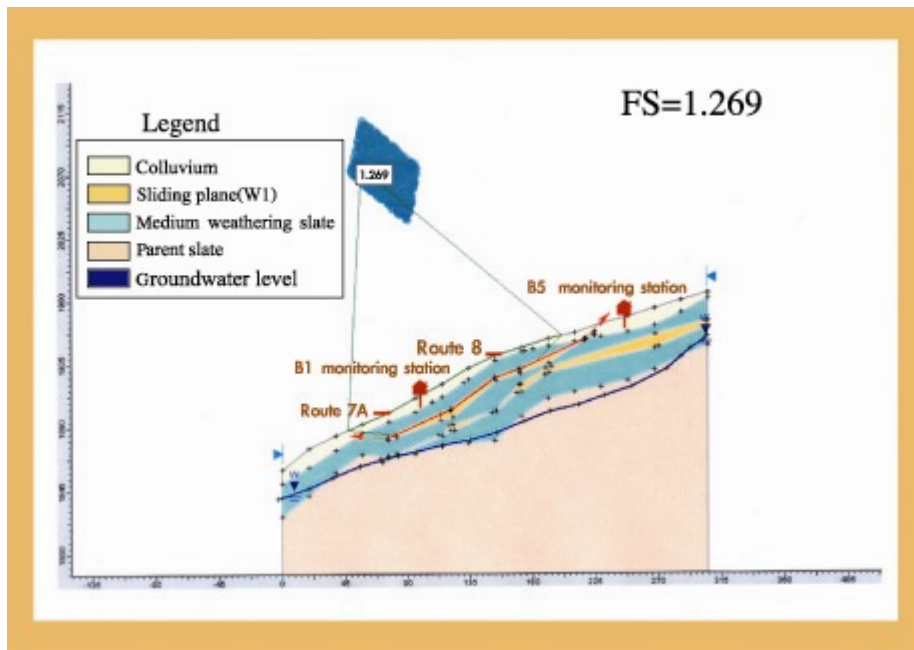
Fig.11 Results of slope stability analysis after remedial work

The primary remediation work conducted for landslide stabilization in Li-Shan area is lower the groundwater level and safely drain the surface runoff. It was estimated that the factor of safety against landslide could be increased up to 1.2 after the groundwater level lowered down approximately 8.5 m. In the collapsed and sliding zone, the slope geometry modification by removing part of the landslide mass was undertaken to ensure the slope stability is safe before the transportation facilities on route 7A was resumed normal condition. On June 25, 1994, the remediation project for Li-Shan landslide was officially approved by Executive Yuan. It was originally designed to be executed for the period of 1995-2000. However, the project was extended from 2000 to 2002 due to the complicated features hydrogeology in Li-Shan existing slide area, which consequently needed an appropriate field

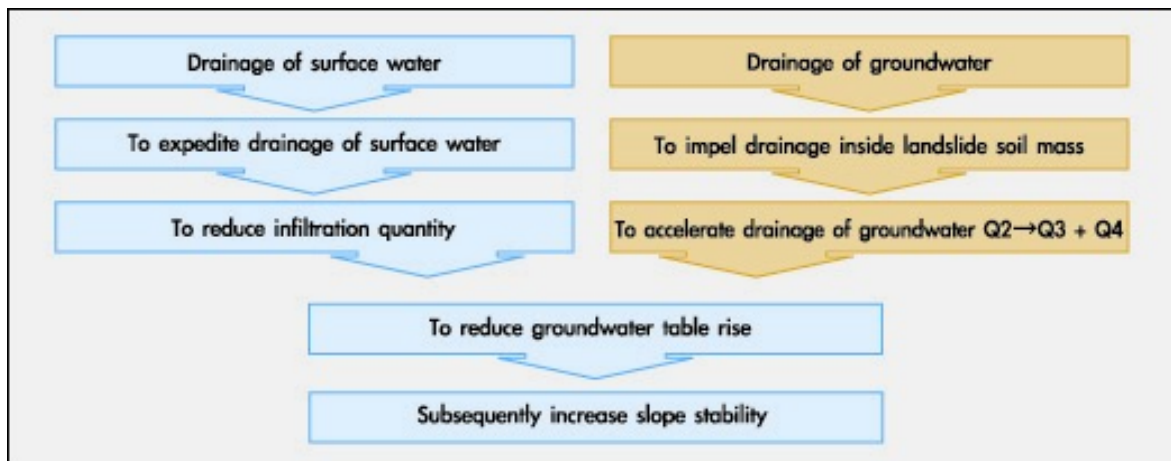
Fig.15 Function of drainage system

In Fig. 14, contents of the drainage system are presented graphically in a profile of slopes. The chief goal is to control the maximum groundwater level. The effect can be explained using Fig. 15 to see their functions.

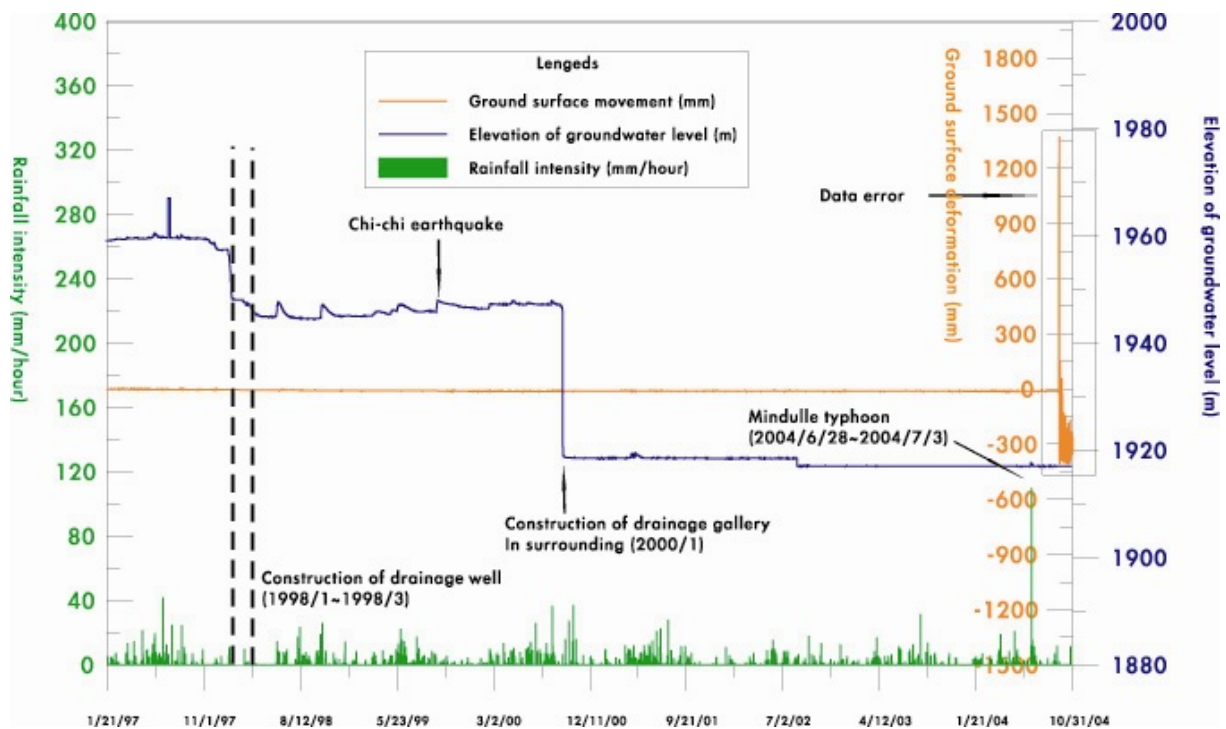
Fig.20 Relation between rainfall intensity, groundwater level and surface deformation in B5 station during 1996/5 - 2004/10

Sliding block B5 monitoring station was located just right above the block B1. The graph shows that the ground water level drops approximately an amount of 15 meters during the construction period of drainage wells, and an extra 28 meters drop was recorded when the underground drainage gallery was excavated and approached to this region. The results also display that little change of surface movement was observed on the wire extensometer, which indicate that the fixed anchoring point of the extensometer might be installed on another sliding block.
