Performance Evaluation on the Renovation Work for Li-Shan Landslides

M.B. Su¹ H.L. Wu¹ L.C. Chan²

¹Civil Engineering Dept. National Chung-Hsing University

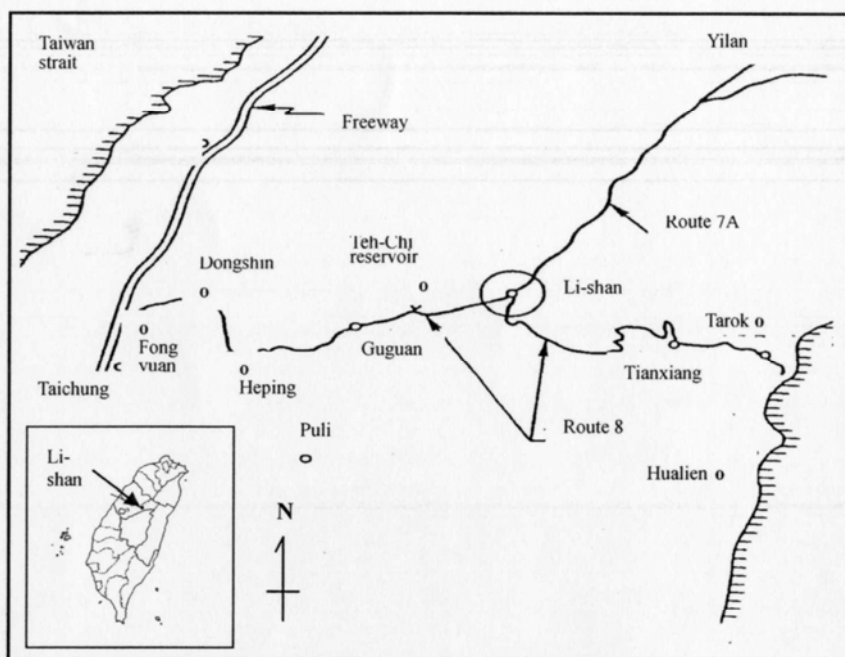
Fig. 1 Location of Li-shan area

As shown in Figure 1, landslide area in Li-Shan village is located at the intersection between the east-west cross-island highway route 8 and route 7A heading to I-Lan. In April 1990, an intense and spectacular landslide hazard occurred in this area following a prolonged torrential rain. The catastrophe lead to destroy the pavement

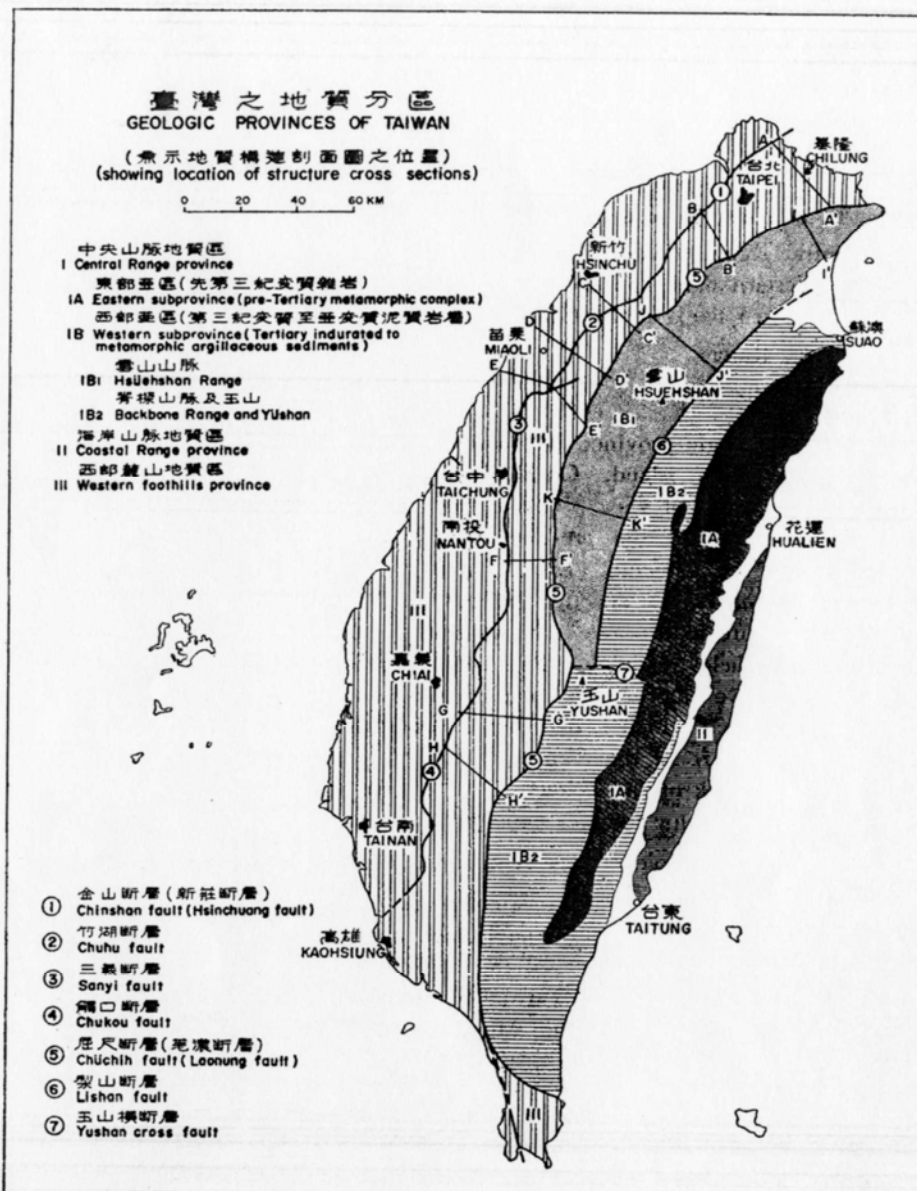
Fig. 3 Geologic provinces of Taiwan (Ministry of Economic affairs, R.O.C, 1975)

In western Taiwan, the westward thrust front due to the compression of the Philippine Sea Plate is obstructed by the rigid basement Peikang High (part of the Eurasian Plate) and result in a series of Quaternary thrust faults trending north-south and dipping towards the east. The 1999 Chi-Chi earthquake is considered as reactivating of one of the active thrust fault, Che-Lung-Pu thrust fault. However, the Li-Shan fault, a major ridge fault of Taiwan island also generated by the above tectonic activity, is located a few kilometers west of the Li-Shan landslide. Geological provinces of Taiwan is shown in Figure 3 as published by governmental agency.

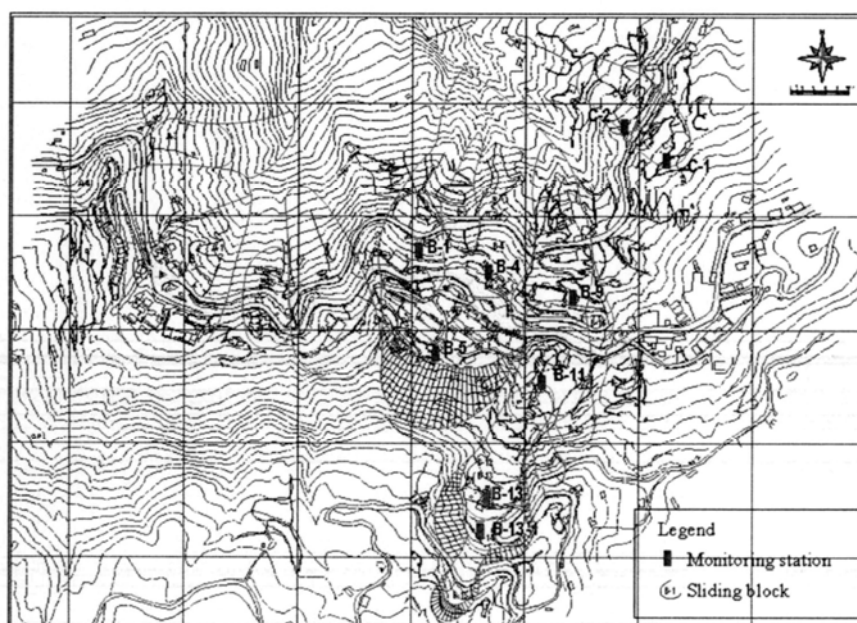
Fig. 6 Locations of monitoring stations in Li-shan landslide area

Eight monitoring stations were set up in this area. Each station were equipped with raingage, piezometer for groundwater level, inclinometer on the surface and into the borehole for monitoring the ground deformation and extensometer for surface movement. Locations of the stations are given in details in Figure 6.

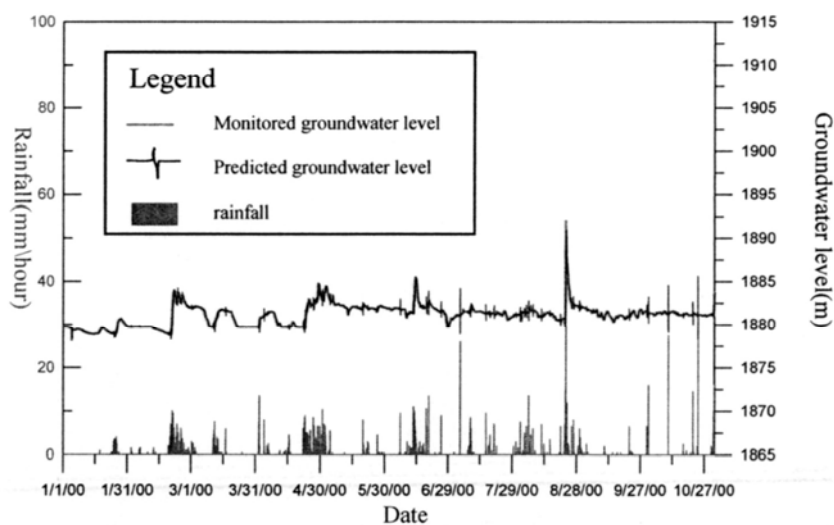
Fig.18 Simulation of transfer function in 2000 (Monitoring station B1)

Time domain ARIMA models for rainfall and groundwater level change are studied. Then, transfer functions for each stations were established between rainfall and groundwater level change. Table 1 showed the optimal transfer function for each station. Time series analysis showed good correlation. Figure 15 shows simulation of transfer applied to year 2000's data for data from monitoring station B1.
