Japan-U.S. Workshop  
on  
Snow Avalanche, Landslide, Debris Flow Prediction and Control

LANDSLIDE MECHANISMS OCCURRED IN A COLLUVIUM SLOPE DEPOSIT

Miau-Bin Su,  
Associate Professor, Civil Engineering Department,  
National Chung-Hsing University, 250 Kuo Kwan Rd,  
Taiwan, R.O.C

**SUMMARY;** A case study was conducted at a landslide located on an ancient colluvium deposit. The mechanism of this specific landslide involves a weak sandy clay layer together with seepage force exerted by groundwater flow during large rainstorm.

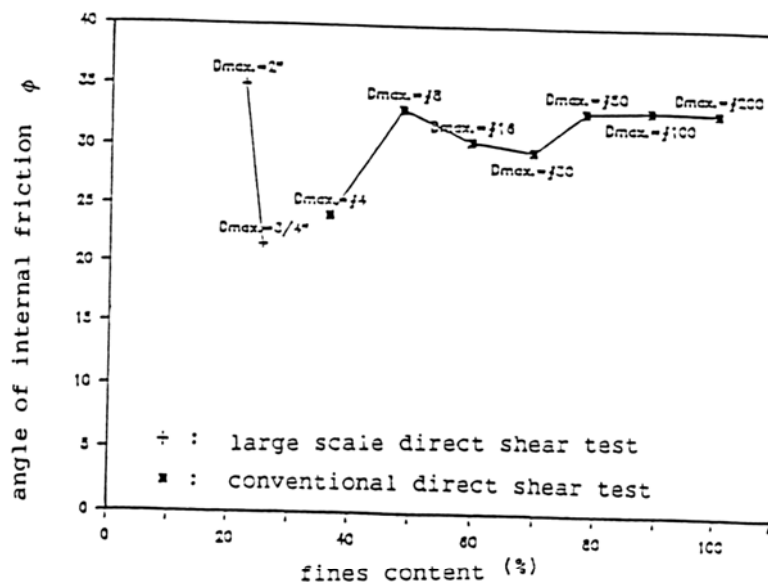
Figure 11. Result of direct shear test of colluvium - The relationship of fines content (f) vs. angle of internal friction ( $\phi$ )

Because the groundwater level between A-3 and A-1 differed about 9m, This implies that two or more groundwater zones exist. In the direct shear test,  $C$  increased as the content of fines in specimen increased. When the content of fines was more than 60%, the variation of  $C$  was less (Fig.10), and the value approached a constant when the content of fines was more than 78% (Fig.11). The factor of safety (FS) of slope stability was obtained after the analysis of PC STABL5, which  $F.S.=0.82$  (Fig.9).
